Manhole Inspection Summary

Manhole # S29S1_014MH

Location Address: **601 W. Patapsco Ave.**

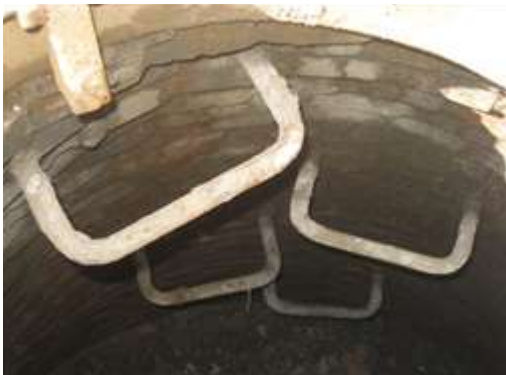
Steps

Count: **4** Missing: **0** ☐ Corroded

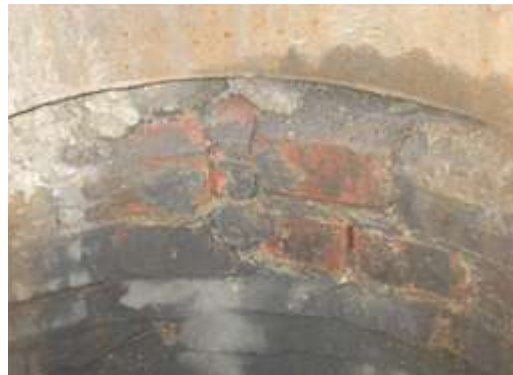
Defect 2

Infiltration: ☐ None ☐ Joint ☐ Cracks ☒ Mortar ☐ Roots ☐ Wall

Mortar infiltration

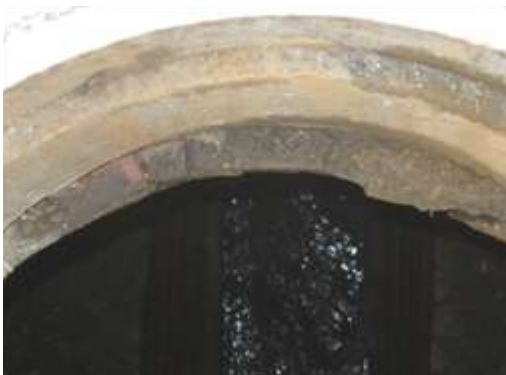
Defect 1

Offset: **1.5** (in.)

Frame offset

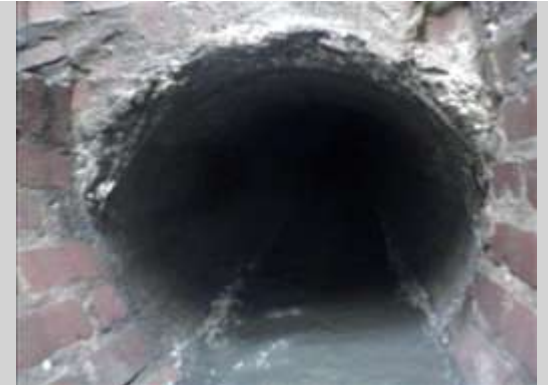
12 O'Clock Outflow

21 in. Circular Gravity Sewer
Pipe Out @ 12 O'Clock

Pipe Height: **22.8** (in.) Rod and Bar (Angled)
Pipe Material: **Concrete** ☐ Pipe Lined
Invert Depth: **9.12** (ft.) Flow Characteristics: **Fast**
Deposits: ☒ None ☐ Mud ☐ Sludge ☐ Debris ☐ Grease
Silt Depth: (in.) Deposits Extent:
Infiltration: **None** Pipe Seal Cond: **Sound**

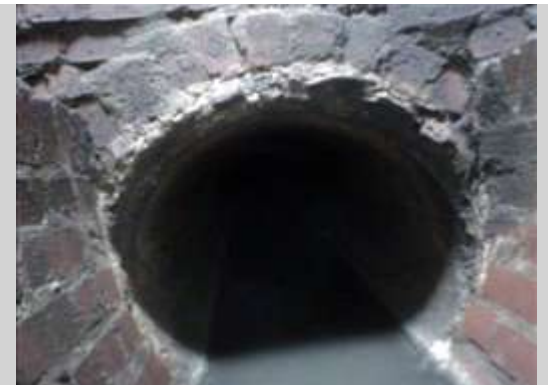
6 O'Clock Inflow

21 in. Circular Gravity Sewer
Pipe In @ 6 O'Clock

Pipe Height: **22.8** (in.) Rod and Bar (Angled)
Pipe Material: **Concrete** ☐ Pipe Lined
Invert Depth: **9.06** (ft.) Flow Characteristics: **Fast**
Deposits: ☒ None ☐ Mud ☐ Sludge ☐ Debris ☐ Grease
Silt Depth: (in.) Deposits Extent:
Infiltration: **None** Pipe Seal Cond: **Sound**
